SEMI-RIGID OR NON-RIGID STRUCTURES  
FOR RE-ENTRY APPLICATIONS

Space-General, a Division of  
Aerojet-General Corporation

FINAL TECHNICAL REPORT AFML-TR-67-310

Part 2 Fabrication and Test

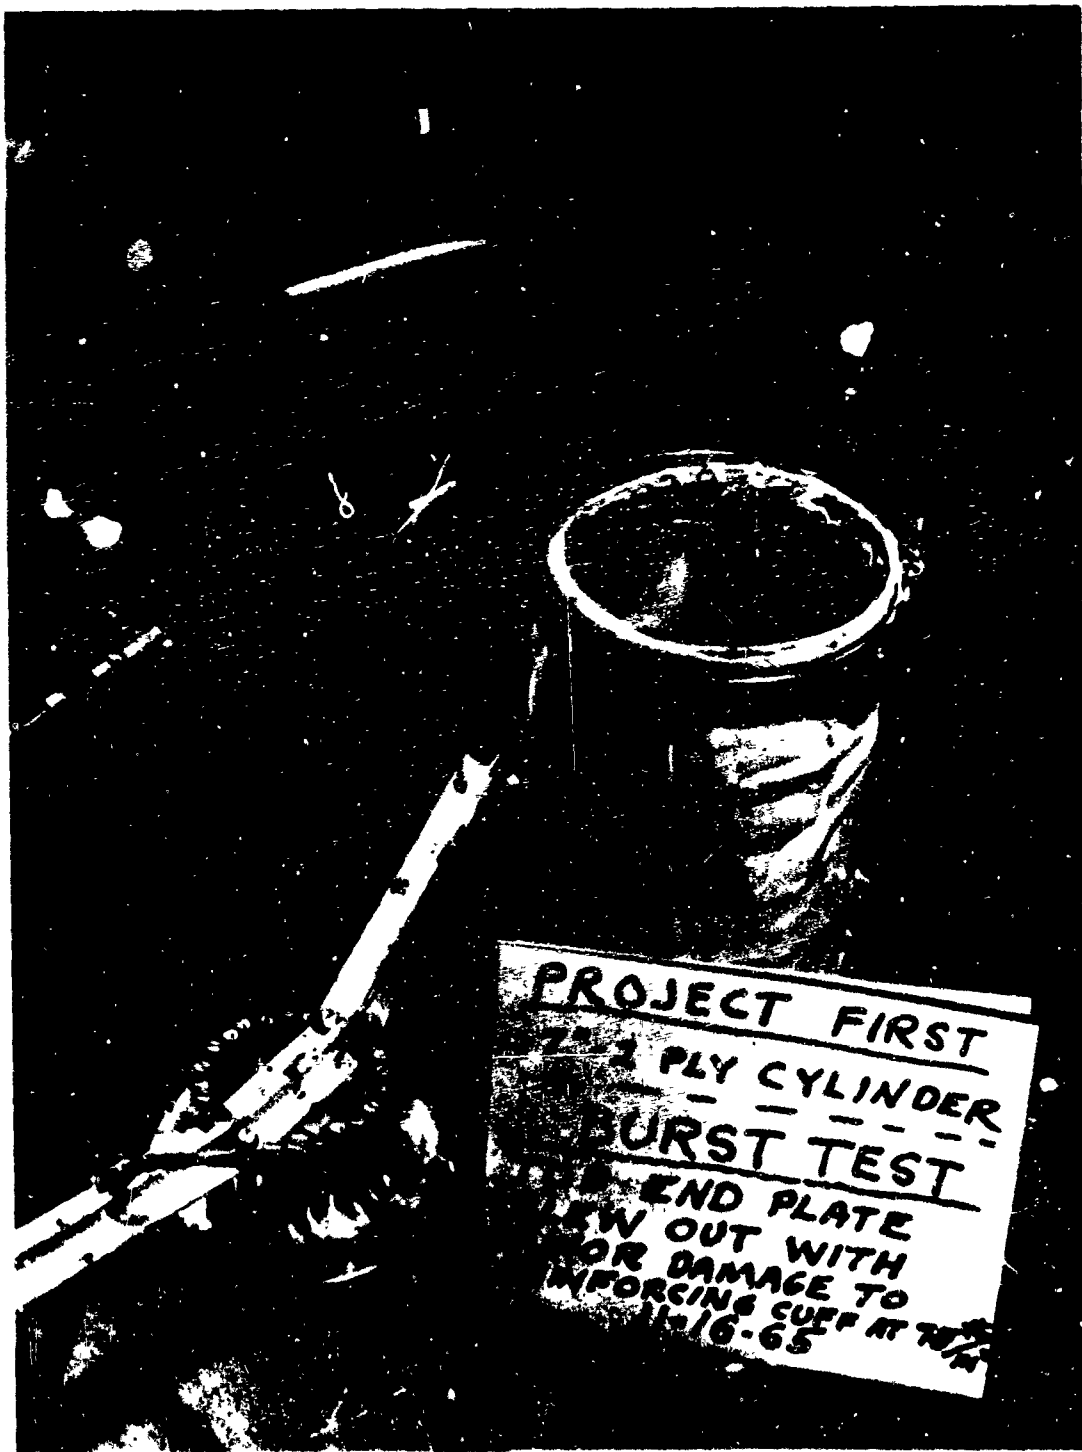
335/221

Figure 214. Two-Ply Cylinder After Failure

Since the design working pressure (corresponding to the full-scale paraglider) for a 7-inch cylinder is 50 psig, the test indicated that the cylinder could stand at least 56 percent excess pressure without bursting. As previously noted, more effective end closure clamping devices were developed so that the maximum strength of subsequent components was determined in actual burst tests. Figure 215 illustrates blisters which developed in the outer S-6510 coating due to obvious pin-hole leakage through the impregnated fabric. Although the S-6510 appears to be homogeneous and leak-free, this property causes small leaks in the impregnated metal fabric matrix to delaminate the outer coating. In each case, the blister was punctured with a penknife after which it retracted to the normal contour of the cylinder and the test was continued while maintaining pressure from the regulated pressurizing nitrogen source.

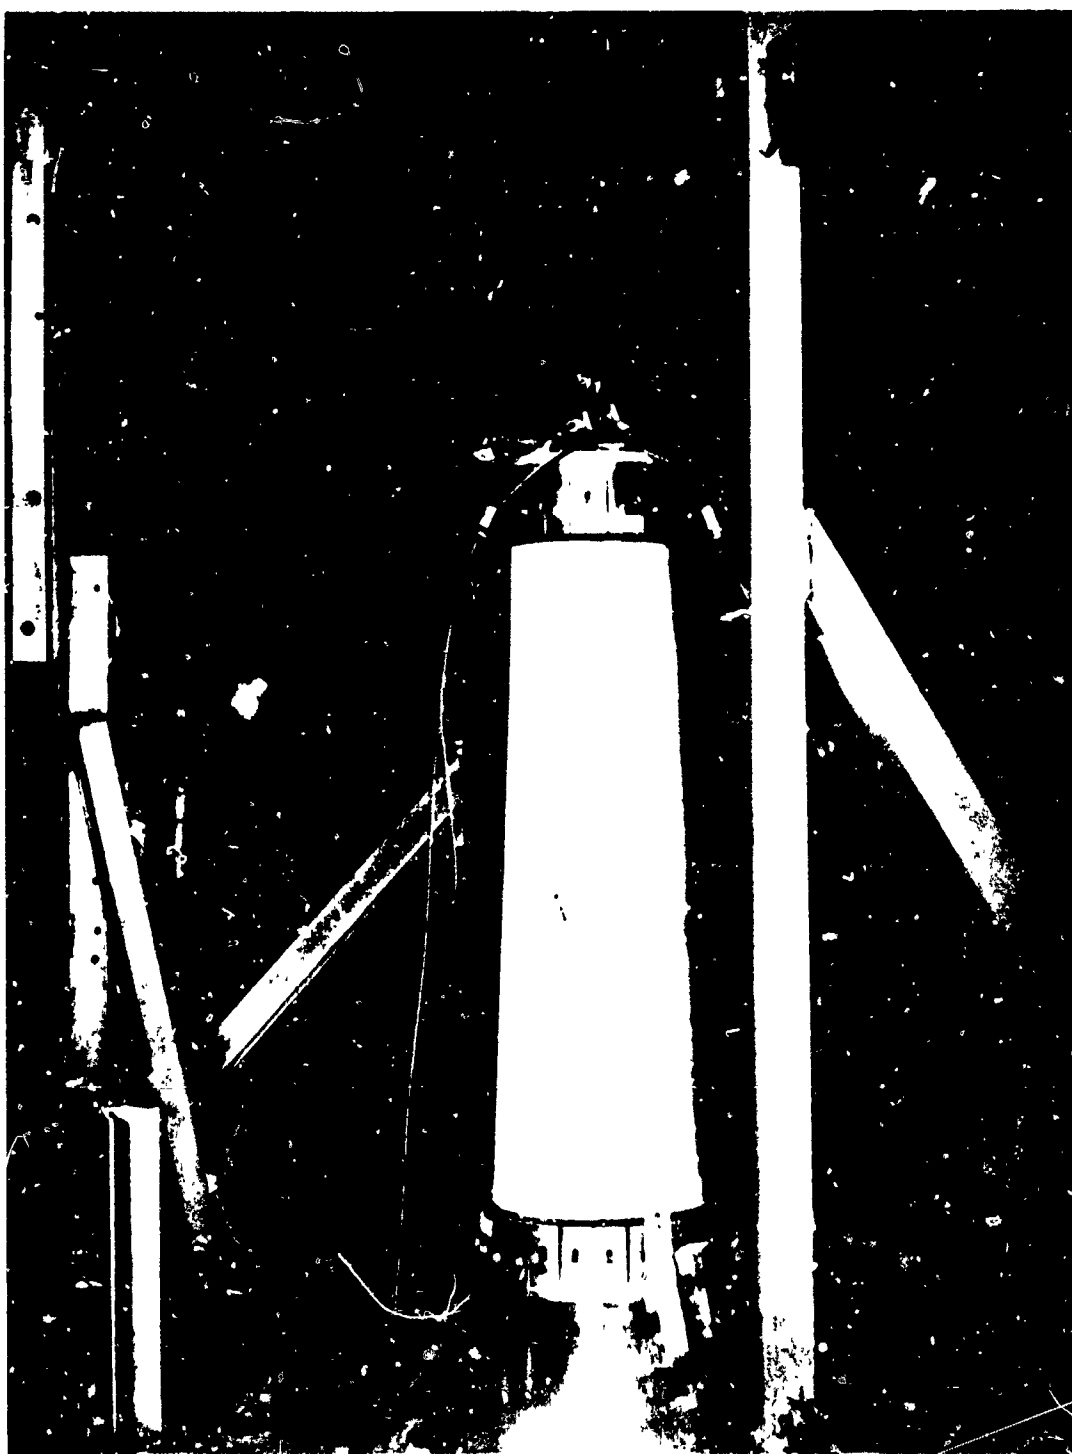
Figure 216. Metal Fabric Frustum in Test Fixture

bottom clamp screws were torqued to 60 in/lb and 40 in/lb, respectively. A 50 psig leak check showed adequate sealing. The specimen was then installed in the test stand with a counterweight of 20.5 pounds to support the weight of the specimen and the upper end closure. Figure 216 shows the frustum in position for testing.

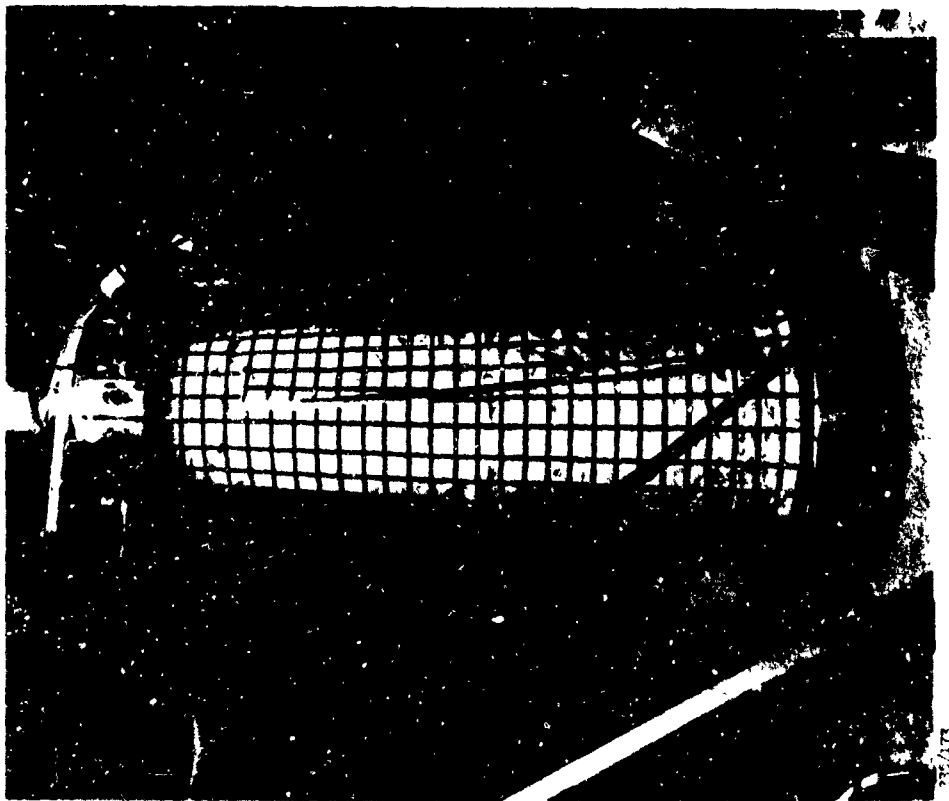
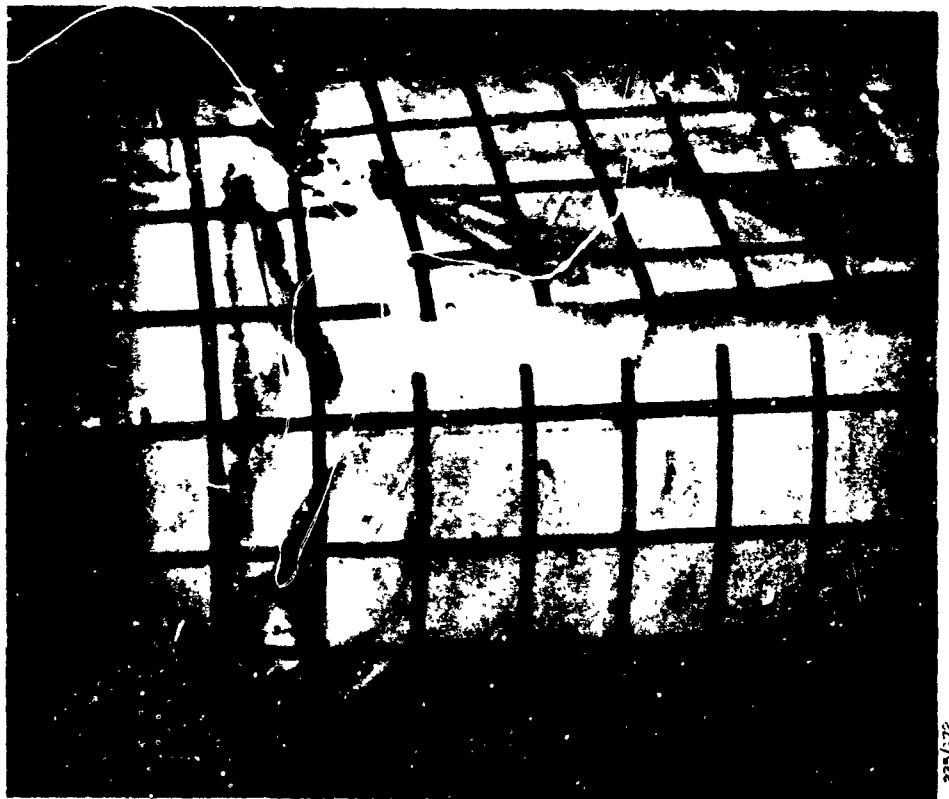
Figure 219. Frustum S/N 2 Prior to Loads Test (Test 3)

This frustum showed evidence of some wrinkles in the area immediately below the small end cuff. The wrinkled zone was about 1.3 inches long and 250° around the periphery as seen in Figure 219. Considerable abrasion was noted on the inside surface of the RTV 655 at the extreme ends of the specimen. It was unknown whether this damage extended into the inner ply of the fabric itself. This damage and wrinkling obviously occurred during the difficult removal from the form tool.

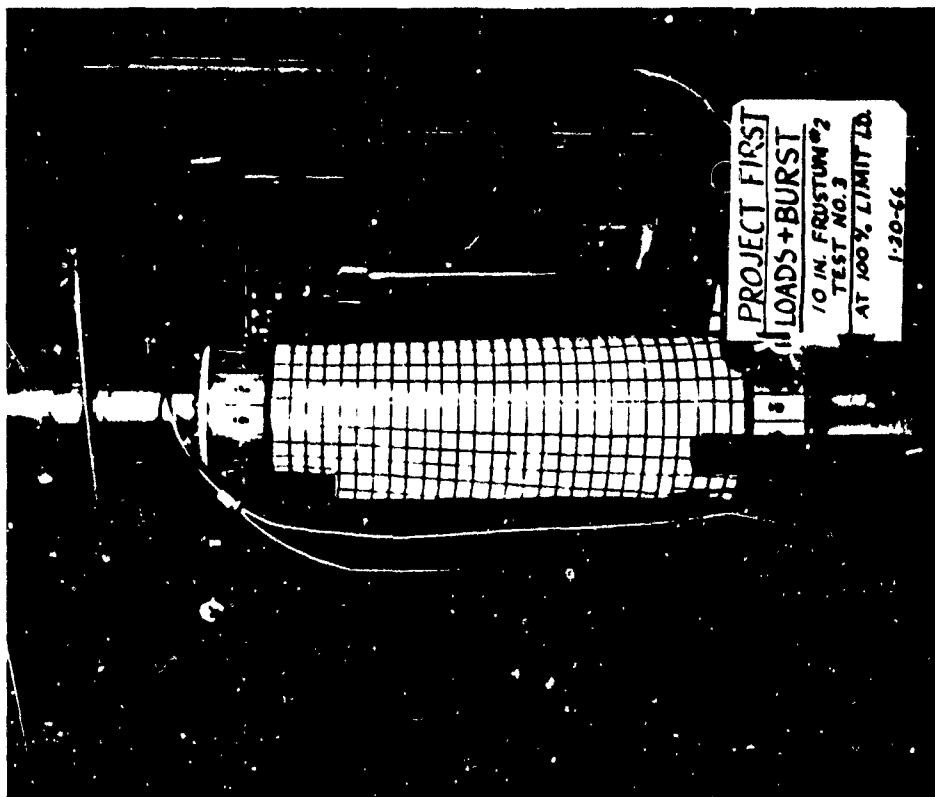
Figure 220. Frustum S/N 2 Under Test at 100% of Limit Load (Test 3)

With the pressure at 35.0 psig, combined simultaneous loads were applied in increments to 33, 67, and 100 percent of design limit. The minimal deformation at 100% limit load may be seen in Figure 220. These loads were then removed while maintaining the 35.0-psig internal pressure and photographs were taken during a 45-minute period. At each of the load increments, deflection data was taken. A tabulation of the combined loads and the resulting deflection data is presented in Table XXXVII.

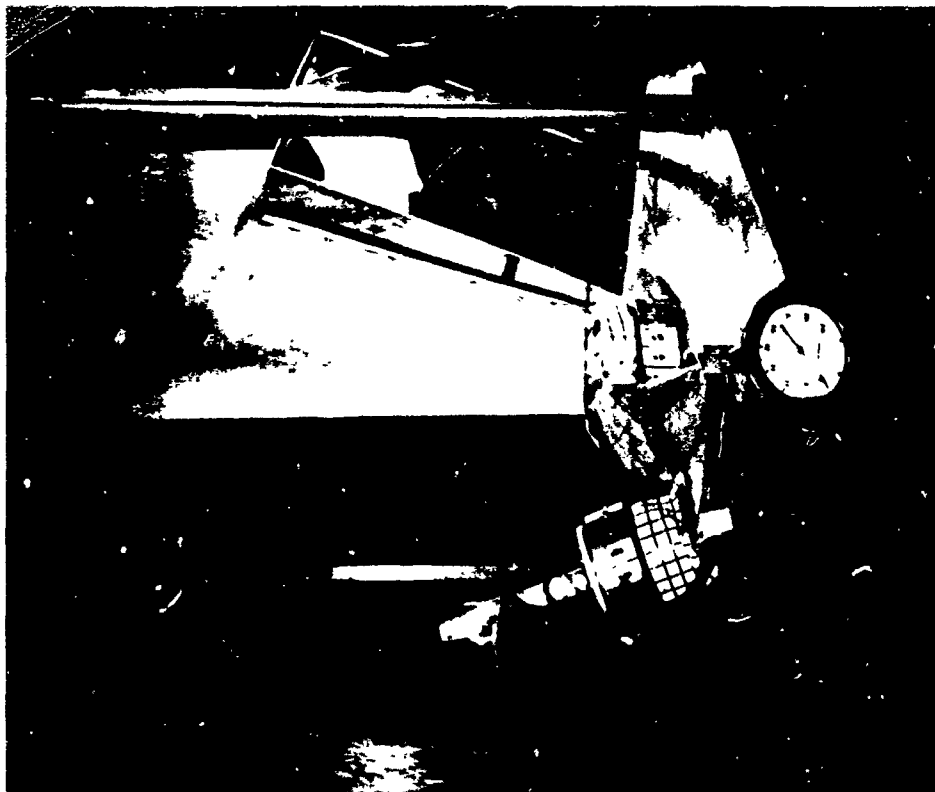
Figure 221. Frustum S/N 2 After Burst Test (Test 3)

The internal pressure was increased at approximately 1.5 psi per second and bursting occurred at 85 psig. This would indicate that the product of the weld efficiency and stress concentration factors was 0.88, using a calculation similar to that presented above for frustum test 2. The failed specimen showed massive damage and the clamp ends were retained in the closure fixture with no discernible damage. Figure 221 shows the burst frustum and mirror broken by the shock wave. As usual the cross ply failed along the side of a longitudinal seam but the extent of the damage to the frustum indicated that the frustum apparently failed in many areas at the same time. The test was considered a significant

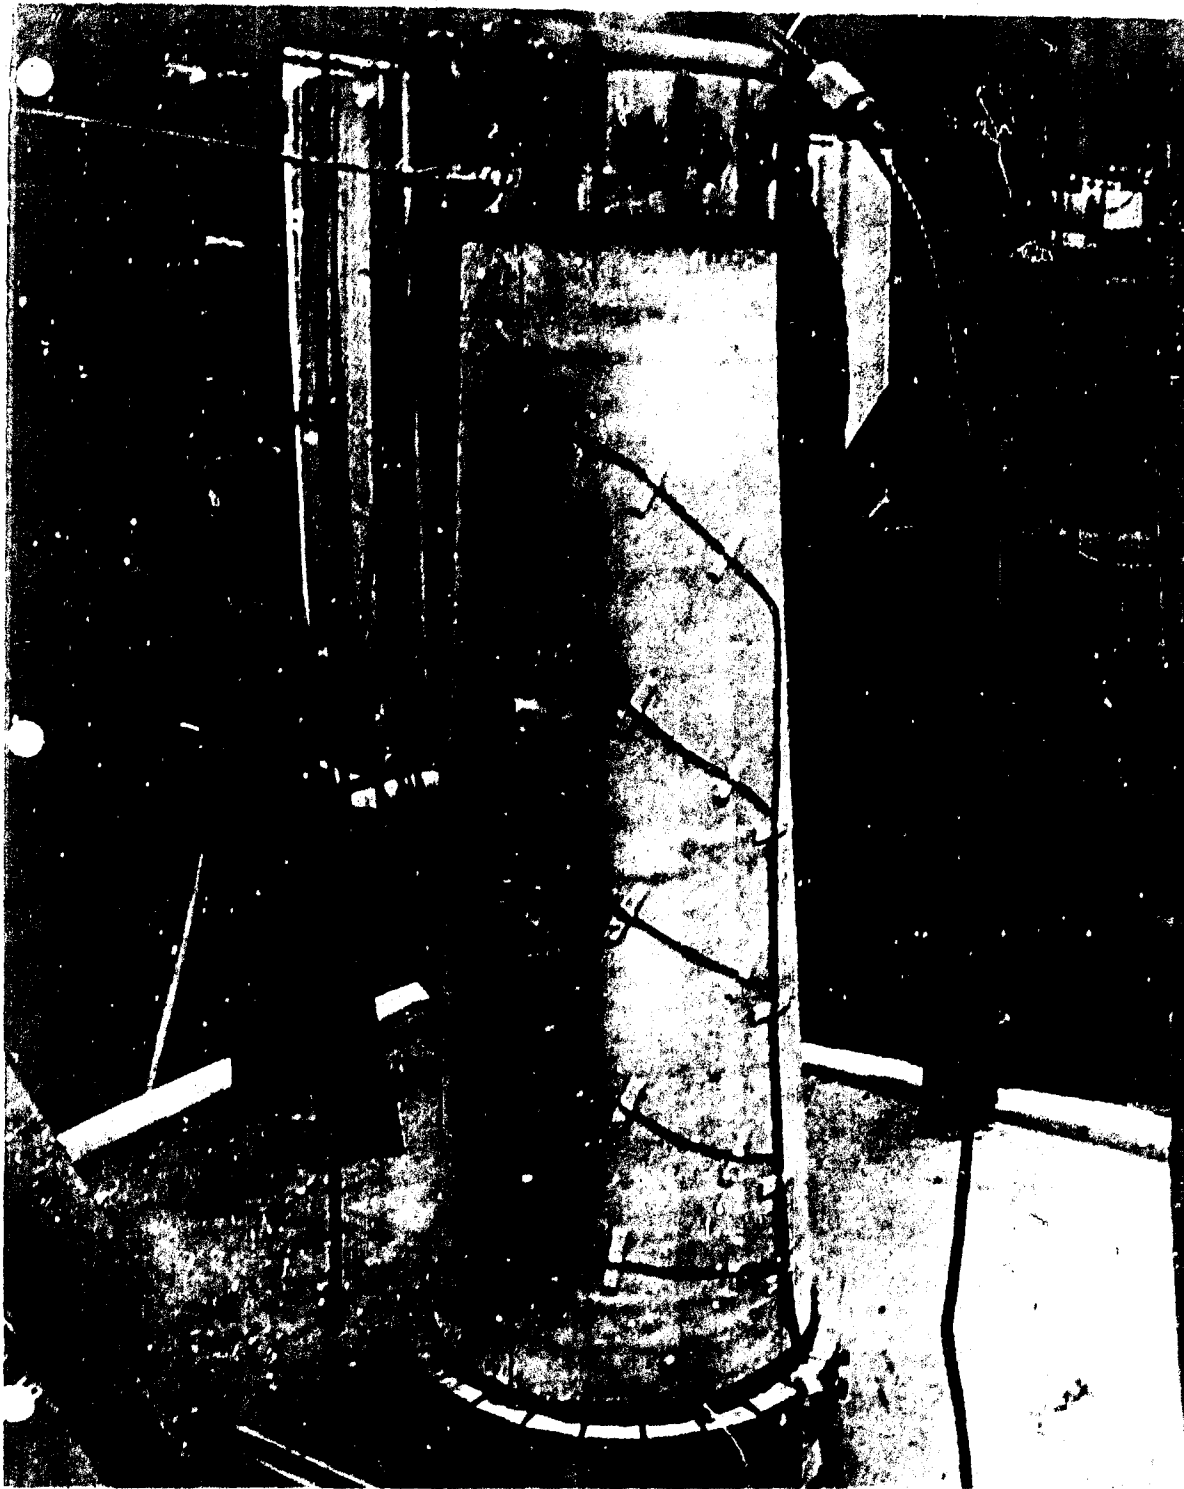
Figure 231. Frustum S/N 4 After High-Temperature Exposure (Test 6)

The post-temperature permeability test indicated that on the 5 to 4 psig test, the times were 49 minutes, 50.5 minutes, and 50.0 minutes. The times required for three tests for the pressure drop from 10 to 9 psig were 18.2 minutes, 18 minutes, and 18.5 minutes. The time required to drop the pressure from 35 to 34 psig was 1.3 minutes. No blisters were observed on this test, but heat delamination occurred after cooling on the outer 2 layers of the silicone rubber coating as seen in Figure 231, but the temperature may have been much higher than 900°F (see Section 3.11.4.8).

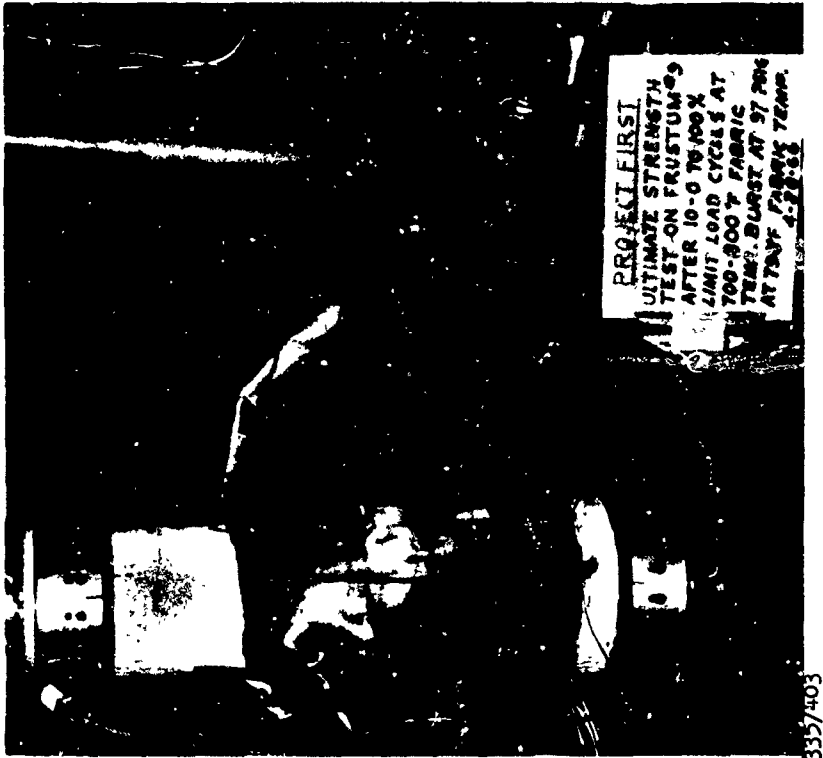
The appearance of the frustum after burst is shown in Figure 250. As usual, rupture occurred along an outer longitudinal seam of the cross ply but in this case the rupture extended almost from one end of the frustum to the other. The usual circumferential tearing also occurred, with the bias ply tearing along a 45 degree axis. Good adhesion between the plies was indicated, however. The vertical tube shown within the frustum is the nitrogen pressurization tube arranged so that the makeup gas is added at the top to offset the collection of hot internal gases which might affect the sealing ability of the top closure.

Figure 250. Close-Up View of Frustum S/N 9  
After Bursting in Test 10
